Yin, X, Lawrence, R & Maskell, D 2018, 'Straw bale construction in northern China: Analysis of existing practices and recommendations for future development', *Journal of Building Engineering*, vol. 18, pp. 408-417.  
<https://doi.org/10.1016/j.jobbe.2018.04.009>

# 1 Straw bale construction in northern China – 2 Analysis of existing practices and 3 recommendations for future development

18 This paper makes recommendations for future straw bale design in northern  
19 China based on an inspection of existing buildings. The issues identified with  
20 existing construction details were subjected to computational simulation analysis  
21 which identified shortcomings in existing practice and proposes revisions to  
22 design detail in order to accommodate the environmental conditions in northern  
23 China. The paper provides a unique insight into current straw bale practice in  
24 northern China and proposes a practical and environmentally sound solution to  
25 the pollution crisis in this region.  
26

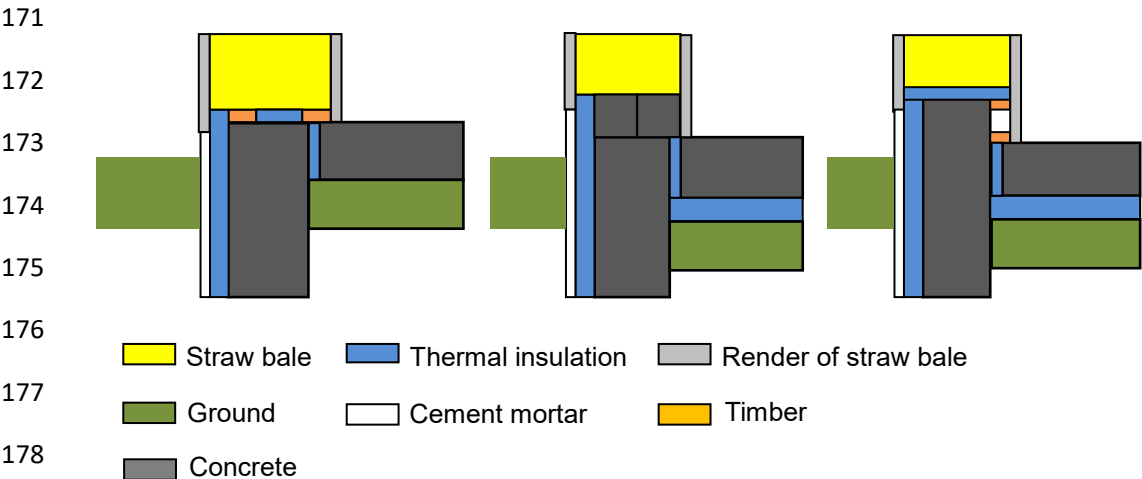
179 Figure 2. Typical toe-up (left), toe-up with blocks (middle) and toe-up with knee  
180 wall (right). (redrawn from (23))

There is a generally accepted constructional approach used to connect straw bales with the foundations to mitigate against damp damage from rising damp (6, 23-25). The construction system is known as ‘toe-up’ and it elevates the straw bale walls off the surface of a slab (6, 23). Toe-up construction ensures that straw bale walls are kept away from ground water damage on slabs during construction and it provides protection against any potential leaks of water (23). There are three typical toe-up designs which are shown in Figure 2 (23). Toe-up construction should both have a vapour barrier layer to prevent damp damage from ground

166 and allow moisture within the straw bale walls to drain away (23). The Toe-up  
167 system is widely used worldwide (23). A development of the typical toe-up is the  
168 baseplate construction which is designed by Jones (26). The baseplate  
169 incorporates the typical timber toe-up construction and hazel pins for fixing first  
170 layer of straw bale walls (Figure 3).

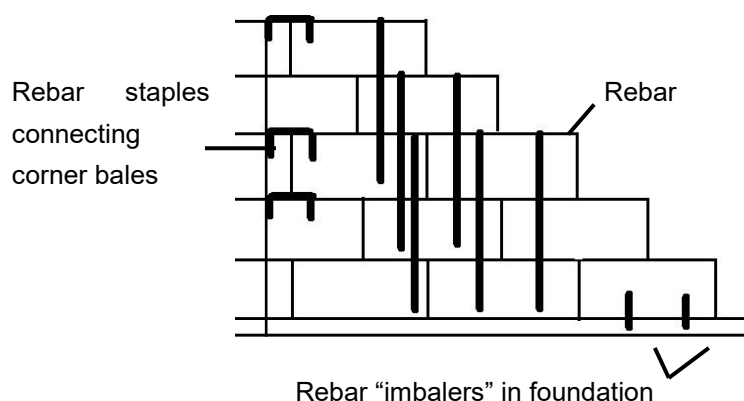
Figure 4. Pinning system for load bearing straw bale walls with 3 tie bales laid flat (24).

In some international examples pins are incorporated to provide structural stability between bales (24). Although the effect of pins is not accounted for in the structural design of in-fill straw bale construction (23), the elements are still essential for the practicality of bale stacking of the walls (6). There are different forms of pins in current practice. Rebar staples and all-thread steel rod with pointed tips are used in load-bearing straw bale construction in the USA (Figure 4). The system is simplified by using natural shaped hazel studs by Jones (6). The irregular shapes of hazel studs provide similar effects as the all-thread steel rod. Because of the wide availability of the raw material, the modification is considered to be a cost efficient and environmentally friendly solution (6). To achieve better integrity of straw bale walls, bales are tied up at corners of first layer of the walls in the hazel pin system (6). However, due to the weakness of the ties, this tie-up construction cannot be accounted for in any structural calculation (6).

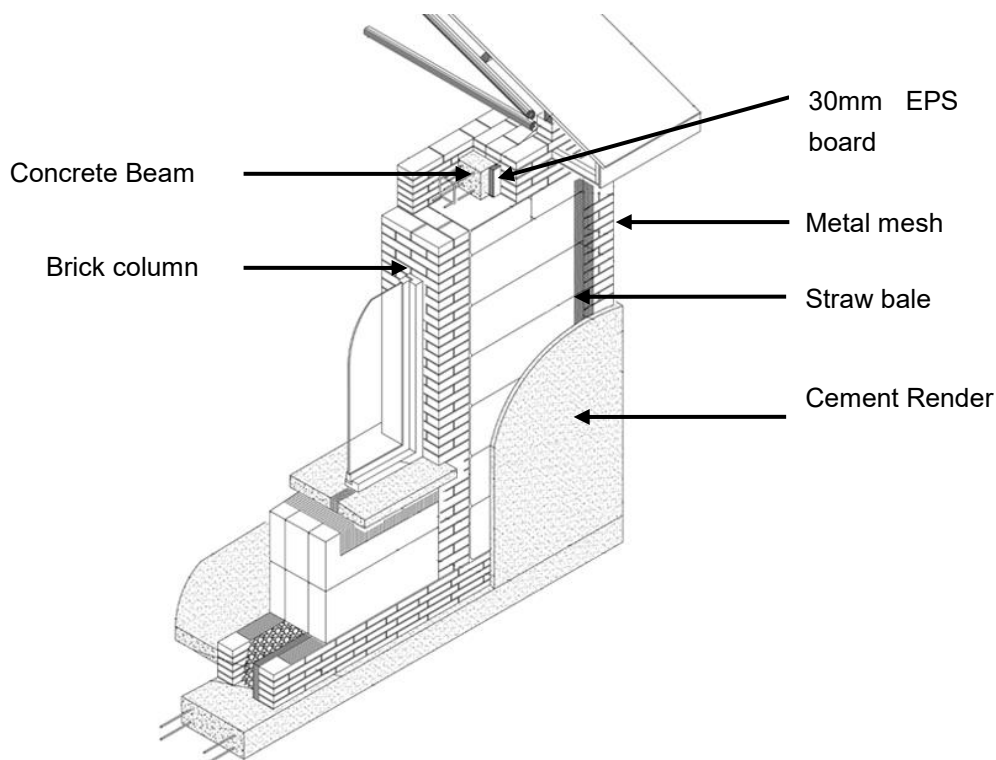
264 Figure 5. Construction detailing of ADRA straw bale buildings. (29)

258 building can reference from the design guide book. The straw bale houses are in-  
 259 fill straw bale construction. The load-bearing structure is masonry-concrete  
 260 (Figure 5). The bricks support the vertical load of the buildings and a poured  
 261 concrete beam serves as ring beams and lintels over windows and doors.

267 The design of the structural frames may form serious thermal bridging during cold  
 268 winter months in Jiamusi. The design of the insulation layer of the structural  
 269 elements are not consistent in the ADRA project and the following design guide  
 270 book published by DCHP. The insulation layer only partially cover surface of  
 271 concrete beam and therefore there is clear pathway of heat loss through the  
 272 masonry bricks around the concrete frame (Figure 6). Due to the high thermal  
 273 insulation property of straw bales, it is speculated that the high thermal  
 274 conductivity of bricks and concrete used for the supporting pillars and lintels are  
 275 not moderated by the use of sufficient insulation material. This design is likely to

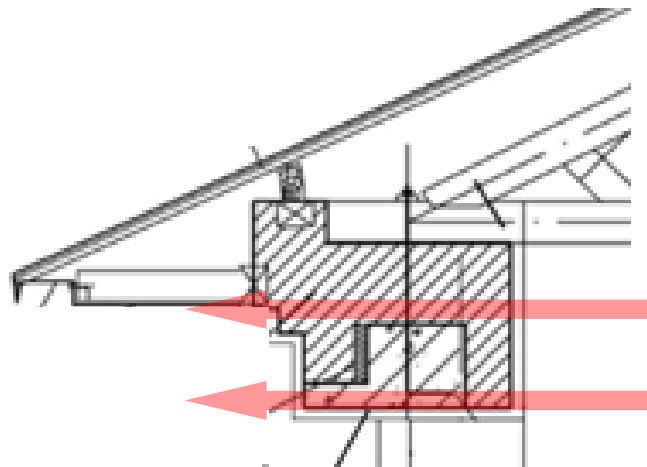
Figure 6. Thermal bridging issue and heat loss pathway (red arrow) in the ADRA project during winter months.

As heat loss are majorly through the structural frames of the straw bale buildings in the ADRA project, potential condensation issues would be serious in the straw bale buildings. Problems caused by interstitial condensation may lead to serious mould growth on the internal surface of walling construction in the ADRA project. Besides, due to a lack of experienced builders who are familiar with constructing straw bale buildings in China, the consequences may be even more serious in real situations. The worst case scenario is likely to relate to frost issues at internal corners.

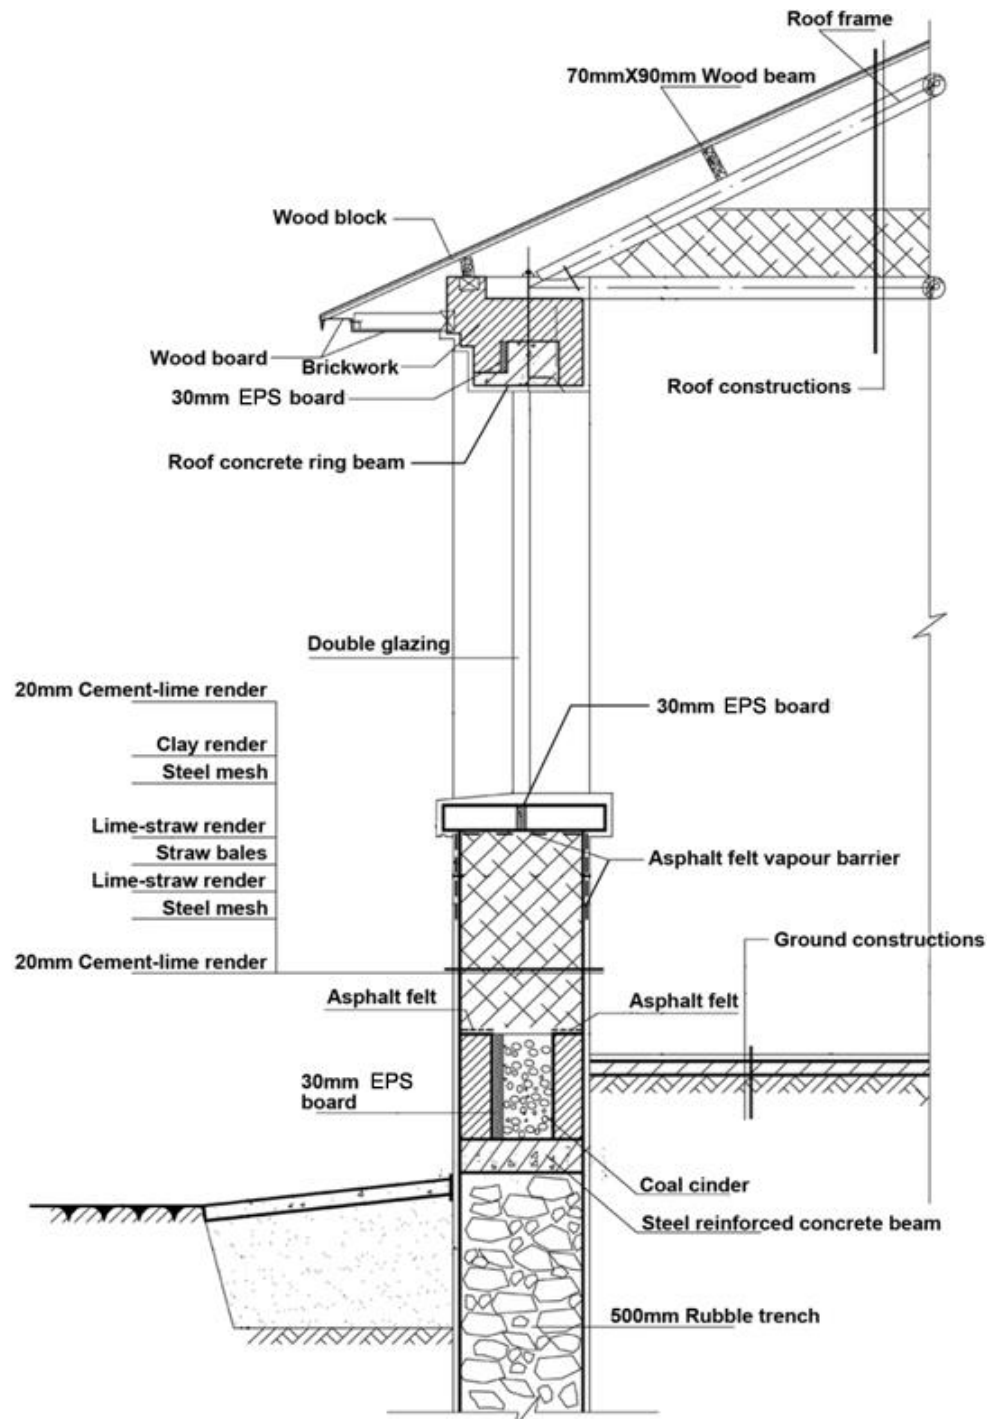
Figure 7. Reference wall section in the ADRA project. (Translated from (29))

299 designs are similar to typical farmhouse designs in the region (Figure 7). Damp  
300 proof courses are installed both beneath the windowsill and on the top of the  
301 foundation. A French drain formed by a trench filled with coal cinder acts to  
302 remove water away from the straw bale walls (29).

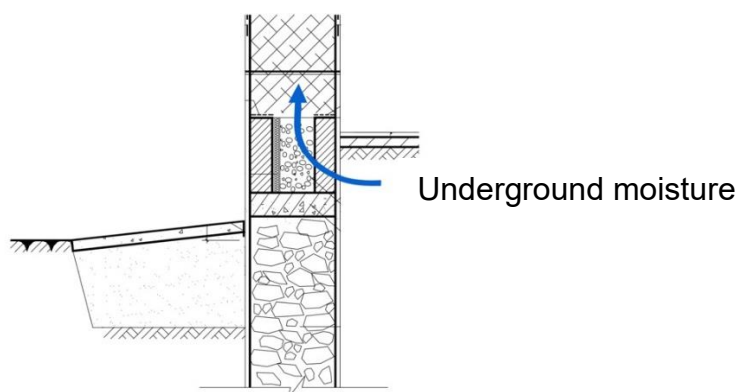
Figure 8. Potential ground damp damage routine (blue arrow) of foundation design of ADRA project

Firstly, the toe-up design is different in China. A unique toe-up which is innovated from the knee wall toe-up is used in the ADRA project. The knee wall is formed by brick and a trench of gravel. The foundation design of the ADRA project may not fully serve the purpose because of the direct connection of the masonry work to the ground (Figure 8). As the damp issues are long term processes, any water damage may not be initially evident (6, 24). Bale conditions within the walls will be a concern after long term exposure to moisture.

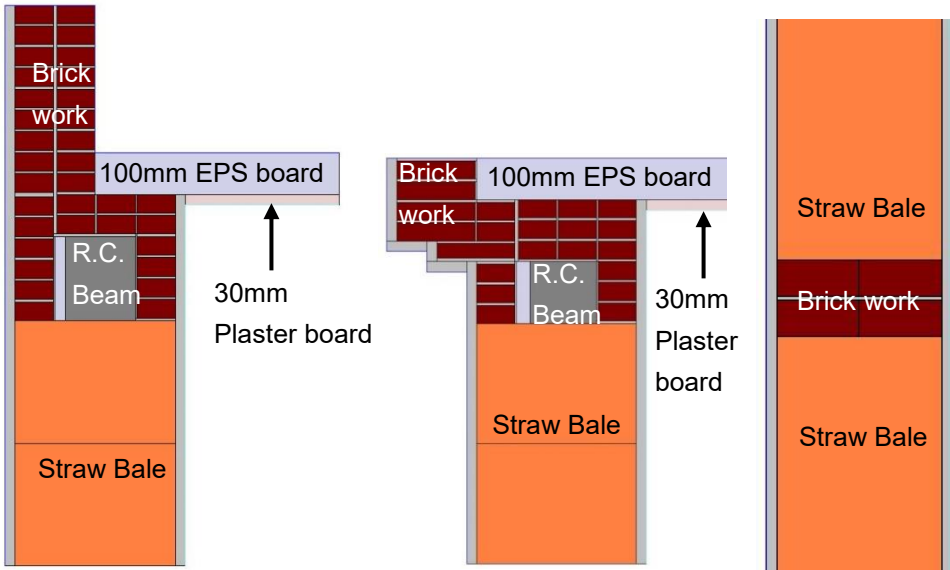
Figure 9. The joint construction of sidewall (left), Joint construction of south and north wall (middle) and section of sidewall in the THERM simulation

434 To verify the hypothesis of thermal bridging issues, the ADRA design is simulated  
435 using THERM. The simulated areas are the joint construction of gable ends and  
436 straw bales, the joint construction of south and north walls and a section through  
437 the gable ends (Figure 9). There are three sections of walls in the simulation  
438 process. There is no specific drawing of joint constructions of walls in the  
439 published design collection. The joint constructions can be deduced from the  
440 drawing of construction detailing (Figure 2) and the design of the wall section  
441 (Figure 3). The wall section is referenced from the layout of the design of  
442 farmhouses in the published design collection (Figure 10).

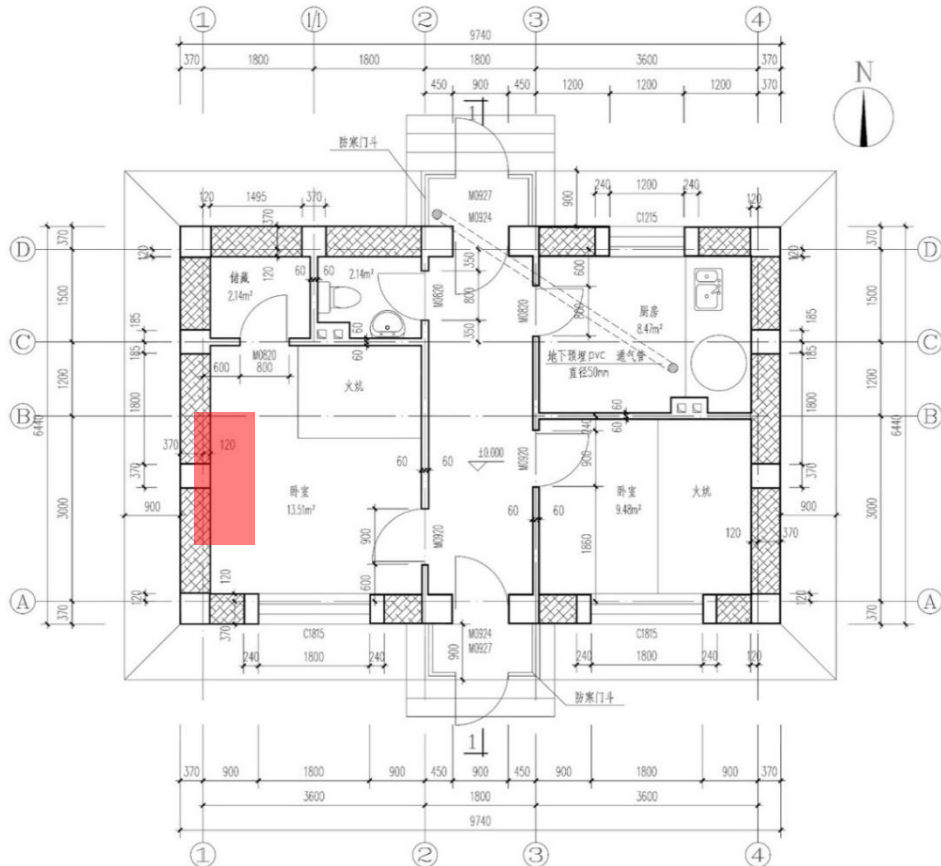
Figure 10. Layout of design of farmhouse in the ADRA project in Jiamusi and simulated section of gable end (in red). (Redrawn from (29))

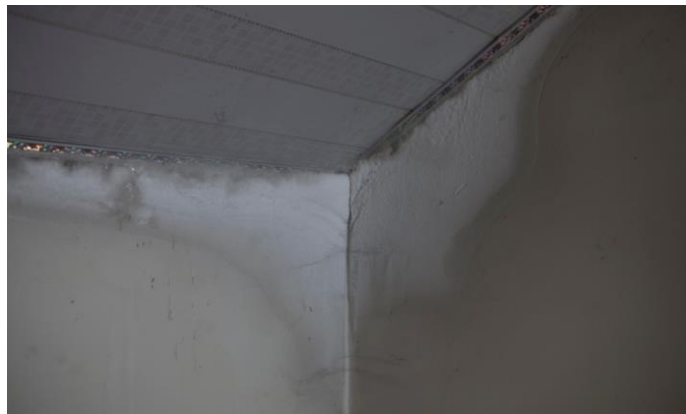
Figure 11. Condensation at the junction of the north wall and the west wall inner corner of one of the straw bale house in Jiamusi.

Firstly, condensation was found on the internal corner in the inhabited straw bale houses. The surface temperature on the internal corner is lower than the freezing point and the liquid condensation developed into frost during the visit (Figure 11). According to the owner of the farmhouse, the condensation is serious on the internal surface of sidewalls. The owner also reported that the frost appears from late December to early January when the lowest air temperature appears annually. However the problem was never happened on the internal surface of either the south wall or the north wall.

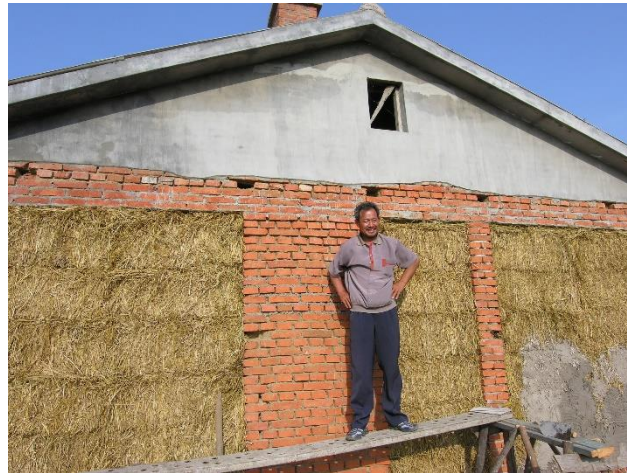
Figure 12. Detailing beneath external rendering of gable end in the ADRA straw bale building project in Jiamusi. (33)

A second problem is linear cracking on external surface of gable ends. The cracks were observed both on the inhabited house and the uninhabited house. It is important to appreciate the detailing of gable ends to understand the cracking issues on the walls. Making use of the photograph which was taken in 2006, the construction beneath the external plaster can be appreciated (Figure 12). The construction of gable end is similar to the construction of non-opening area of south walls and north walls (Figure 2).

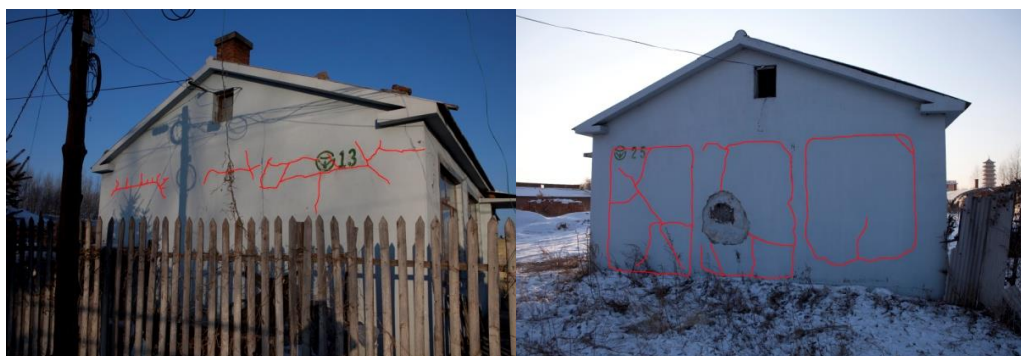
Figure 13. Cracks (highlighted in red) on surface of brick frames (left) and between straw bales and frames (right).

The cracks were observed both on the surface of brick frame of gable ends and between the structural frames and infill straw bale walls (Figure 13). As the owner of the straw bale house indicated, the cracks were formed during the first winter after the completion of the construction in 2006. The metal mesh between brick frame and straw bales failed to resist crack generation. Because of the serious cracking issues, the owner of the uninhabited straw bale farmhouse decided to move out 4 months before the on-site visit by author. Because cracking issues have a close relationship with straw degradation (23), the straw in gable ends is expected to be in a poor condition. Straw degradation was identified by drilling an opening on the gable end of the uninhabited house (Figure 14). Decolourization of straw behind rendering construction as well as the rusty metal mesh were identified in the opening. Due to low temperature ( $-19^{\circ}\text{C}$ ) during the onsite visit, moisture in the straw bales freeze the straw bales firmly. As a result, there is no sample was taken from the drilled opening.

beam forms clear thermal bridging in the joint design of south and north wall design. The heat transmittance figure shows that heat is exchanged more rapidly through non-straw bale elements and the more frequent temperature cycling may lead to thermal shock issues during external temperature swings around the freezing point which will lead to cracking on the surface, as has been observed from figure 13.

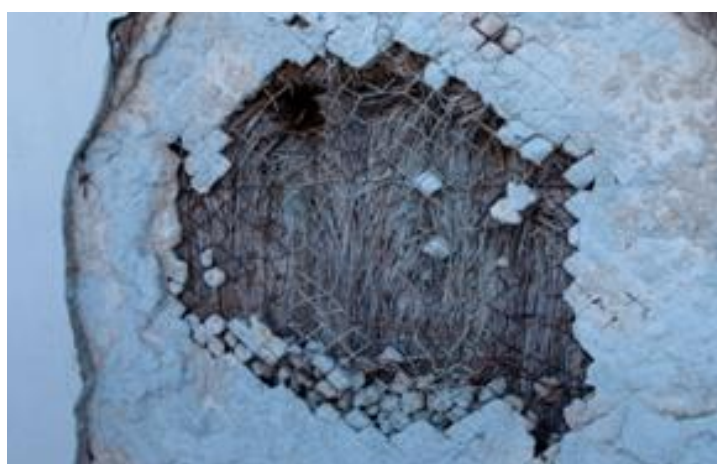
Figure 14. Straw degradation in the gable end of a non-resided straw bale house in ADRA project.

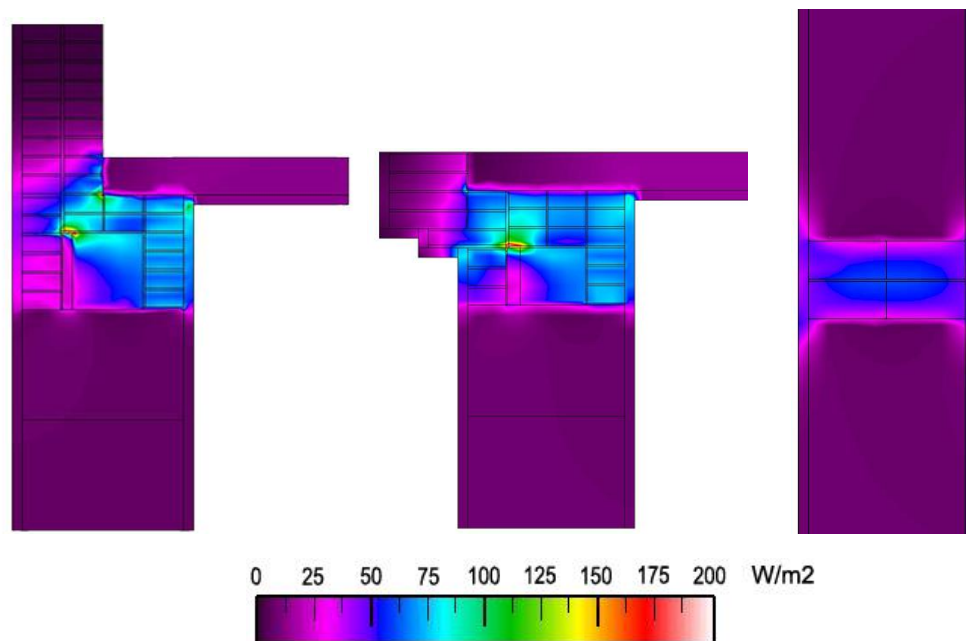
Figure 15. Thermal transmittance of the joint construction of sidewall (left), Joint construction of south and north wall (middle) and section of sidewall in the THERM simulation

The simulation results show serious thermal bridging issues in the ADRA project in Jiamusi. The majority of the heat loss is associated with the non-straw bale elements (Figure 15). There is a clear linear boundary at the straw bale and brick-concrete interface in the thermal transmittance figure. Heat transfer through straw bales is close to 0 W/m<sup>2</sup> whereas it is 26-36 W/m<sup>2</sup> for the brick work for the joint design and 26-53 W/m<sup>2</sup> for gable ends. The concrete beam conducts the most heat through internal space to outside. The high conductivity of the concrete ring

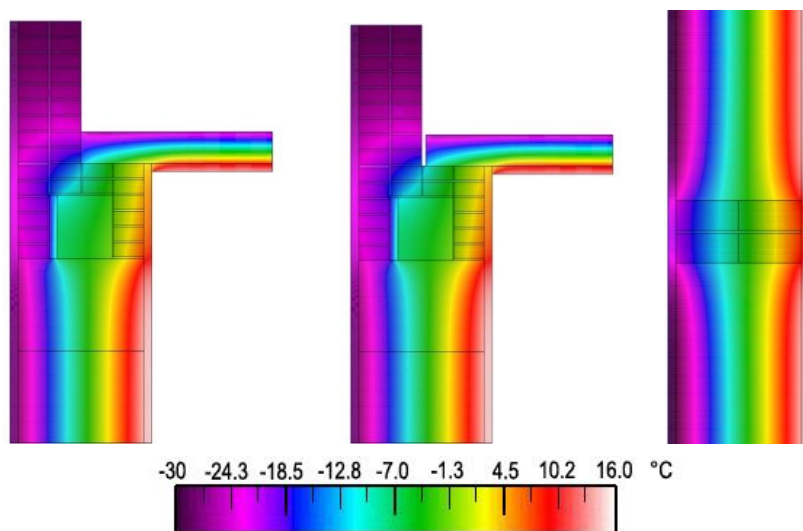
Figure 16. Temperature distribution of design joint construction of gable end (left), realistic joint construction of gable end (middle) and gable end section (right).

The heat transmittance data indicate potential for rapid temperature changes at the external surface. The external surface temperature differences in the simulated situation can be used to estimate the potential for differential thermal expansion of the external surface. According to simulation, greatest surface temperature difference occurs on the gable end section and the joint construction of the gable end. The surface temperature of cement mortar is approximately  $-30^{\circ}\text{C}$  on straw bales whereas the temperature can reach  $-23^{\circ}\text{C}$  on surface of masonry

bricks (Figure 16). The simulation results explain the linear cracks on gable ends. The large surface temperature difference can lead to differential temperature expansion issues within external surface render. Because cement render is weak in tension, the cracks are likely to occur and can have serious consequences, including the ingress of water into the underlying straw bales.

The frost issues on internal surface which is observed can be explained by the gap between the insulation material and the brick work on the gable end walls. The gap between the insulation material and the brick work can result in the surface temperature on internal corner being lower than freezing point (Figure 17). As a result, failed installations of insulation construction as per the design specification have great influence on the internal surface temperature on the gable end walls.

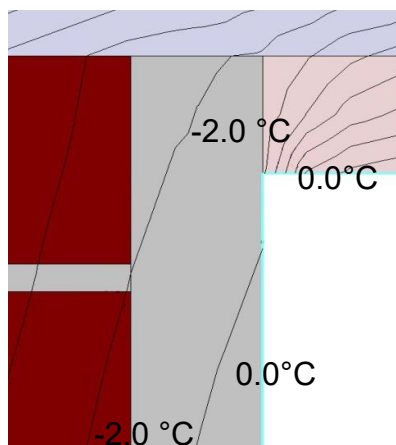
Figure 17. Thermal simulation result of the realistic joint construction within allowable range of error (right)

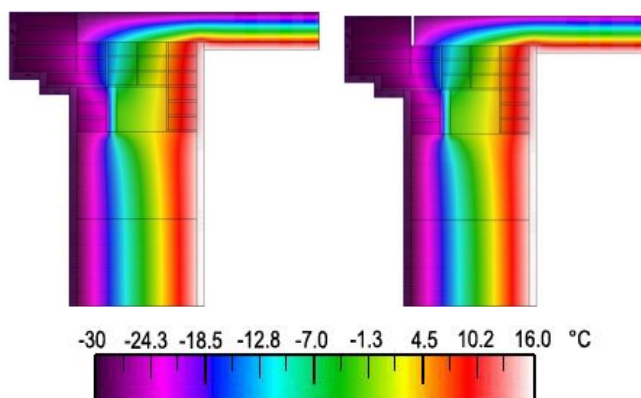
Figure 18. Temperature distribution of design joint construction of south and north

wall (left), realistic joint construction of south and north wall (right)

The situation for the south and north walls is different. Regardless of clear thermal bridging identified in the image of thermal transmittance, there is no significant surface temperature variation on the south north walls in the simulation. The surface temperature was similar in both design joint construction and realistic joint construction (Figure 18). The situation can be explained by the decorative overhang brick construction at the eaves. The additional thickness of brick provides extra thermal insulation to the non-straw bale elements and decreases the variation of the surface temperature. The external surface temperature distribution only initiates differential expansion causing cracking to appear on the gable ends.

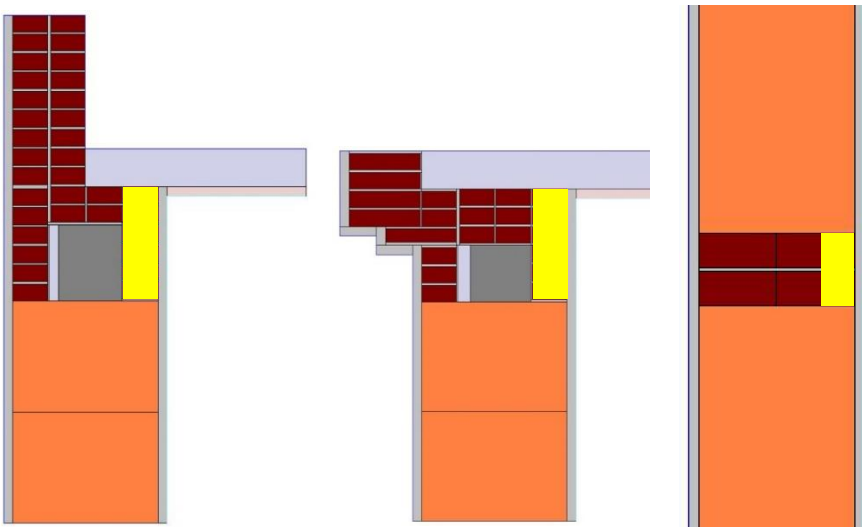
634 Figure 19. Proposed installation of thermal insulation material (yellow rectangle)  
635 in the straw bale buildings in the ADRA project.

1. Design to minimize thermal bridging issues is crucial for straw bale construction in northern China. Without sufficient thermal insulation to the non-straw bale construction components, the external render can have cracking issues which will result in straw degradation. To correct the issues identified in this research, modifications of the existing straw bale buildings are needed. With installation of consistent layer of insulation material to replace the brick work, the identified thermal bridging issues can be effectively fixed in the straw bale buildings in the ADRA project (Figure 19).

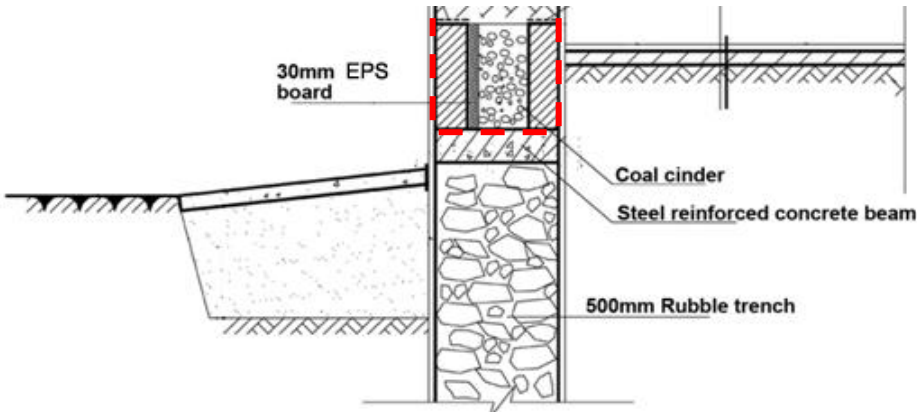
645 Figure 20. Proposed modification of the installation of water proof layer in the  
646 standard design guide book published by the DCHP.

- 637 2. Foundation design should prevent a clear pathway between straw and  
638 underground ground moisture to prevent rising damp issues. As the brick knee  
639 walls in the ADRA project provide are moisture permeable, installation of a  
640 waterproof layer around the brick knee walls should be required for further  
641 construction straw bale buildings which reference the construction detailing  
642 from the design guide book of the DCHP (Figure 20).
